Inspection Report
Minerals Regulatory Program
March 14, 2011

Mine Name: Ticaboo Stockpile Removal
Operator Name: Ucolo Exploration Corporation

Permit number: S/017/0050
Inspection Date: December 1,
2010
Time: About 2:00 PM

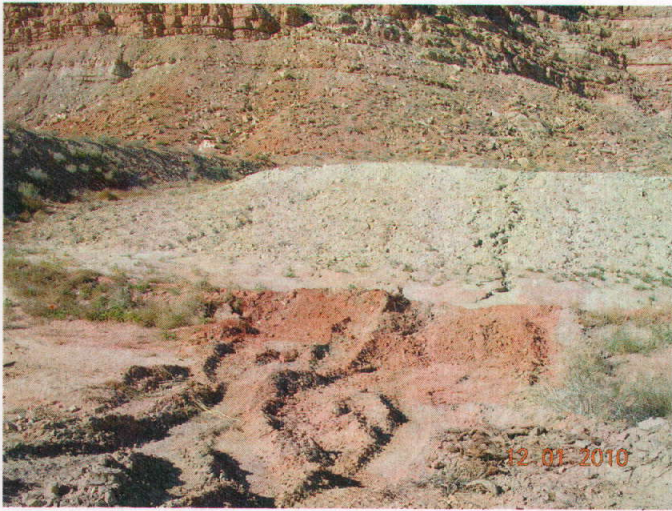
There has been a fair amount of erosion off the stockpile. It appeared the berm had breached in one location but that it had been fixed.

Photo 1. It appears the berm was fixed.

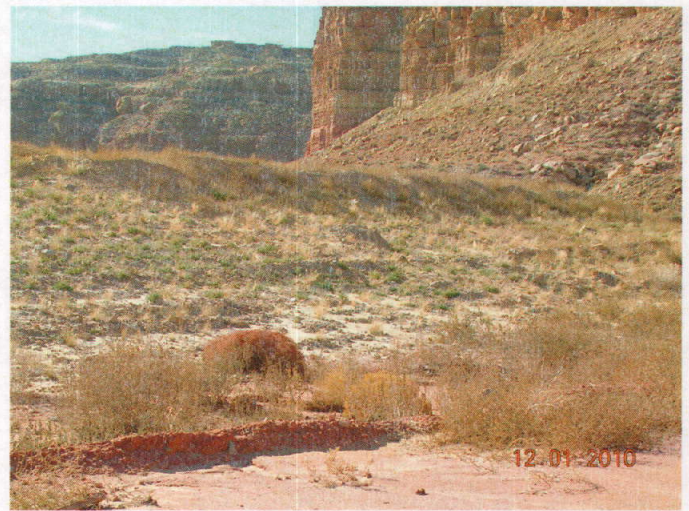
Photo 4

Photo 2. Photos 2 through 4 show some erosion off the stockpile.

I recommend that the ditch on the inside of the berm be cleaned out so it is ready for runoff from the next storm.
